## FIRE: STRUCTURAL AND MATERIAL CONSEQUENCES

Balázs L. György<sup>1</sup>  
Éva Lublóy<sup>2</sup>

**Summary:** *In addition to the mechanical properties, behaviour structural materials at elevated temperatures is also of high importance. Present paper deals with the effects of fire attack on concrete or concrete structures in Hungary. Residual compressive strength of concrete exposed to high temperatures is influenced by the following factors: water to cement ratio, cement to aggregate ratio, type of aggregate, water content of concrete before exposing it to high temperatures and the fire process. Therefore, mix design and composition of concrete are of high importance. Material and structural behavior are analyzed at high temperatures, which, based on practical observations, could reach even 1100°C in some cases. Relationship of concrete mix design and structural behaviour are discussed with test results on prestressed concrete beams. By the analysis of earlier fire attacks, important information can be obtained for future fire design. The fire cases of the Budapest Sports Hall (1999) and of the Athletic Hall of the University of Physical Education in Budapest, Hungary (2015)

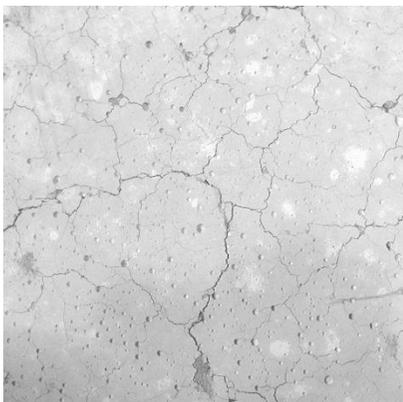
The mechanical characteristics of the concrete are changing subjected to fire. During the cooling process concrete is not able to recover its original characteristics. Deterioration of concrete at high temperatures has two forms: (1) local damage in the material itself (*Figure 1*) and global damage resulting the failure of the elements (*Figure 2*).

Figure 1. Damage of concrete

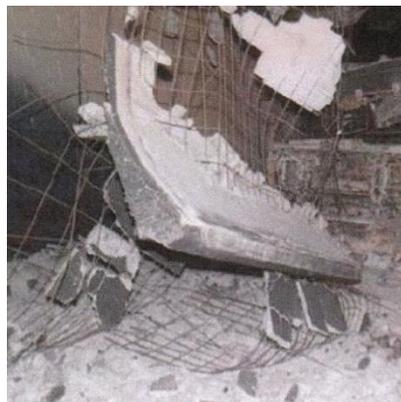
Figure 2. Damage of structure  
(<http://www.polizia.ti.ch>)

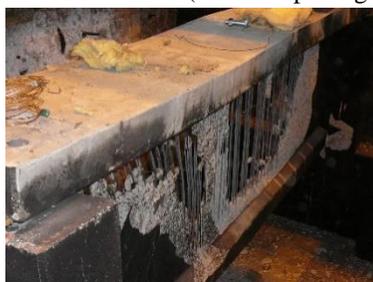
The length of beams was 3.4 m. The prestressing force was 130 kN. First, the beam was loaded with  $P=2 \times 350$  kN during the fire test (Figure 4). Test beam with reference mix (Mix 1) failed in 12 minutes owing to the complete spalling of concrete cover of the web (Figure 5). Test beam with Mix 2 including  $1 \text{ kg/m}^3$  polypropylene fibres failed in 42 minutes in shear (without spalling of concrete cover). Test beam with Mix 4 including  $1 \text{ kg/m}^3$  polypropylene fibres and slag as filling material instead of lime stone failed in 67 minutes in shear (without spalling of concrete cover).

Figure 5. Beam with the reference

concrete (Mix 1) after failure 2010, Szentendre, Hungary [7]

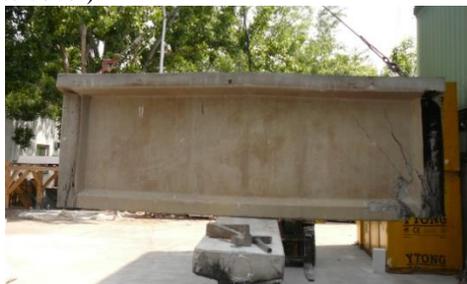
Figure 6. Beam with Mix 4 after failure

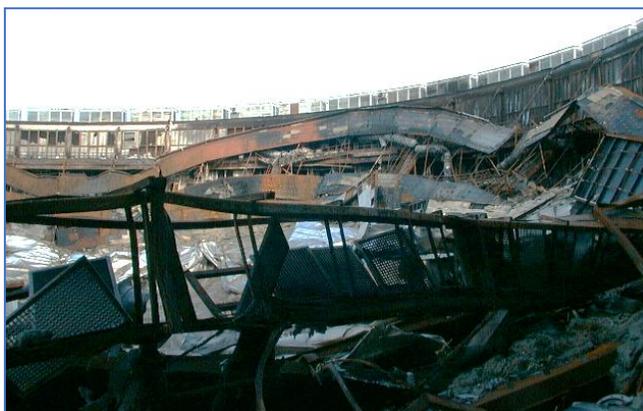
Figure 7. The deformed steel rings, Budapest Sports Hall, Dec. 1999[10]

There were cracks on the concrete structures of the 1st and 2nd floors, however these did not influence considerably the bearing capacity and stability of the structure. On the 1st floor 25%, while on the 2nd floor 10-15% of the bearing structures deteriorated in such an extent that measures had to be taken. The most considerable strength and structural damages were observed in the materials of the area of the cloakroom on the 1st floor, where, all concrete structures suffered strong or medium damages. The damages of the pillars were not significant, however the displacements and cracks implied structural movements. On the basis of inspection it could be said that the 2nd floor suffered lower fire attack; here, damages of smaller extent of probably local character occurred. The bearing structures suffered the most severe damages on the 3rd floor. The steel structures suffered considerable deformations (*Figure 7*) during the fire.

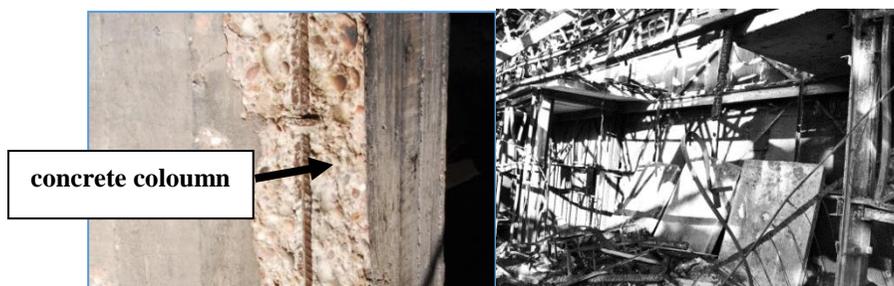
At some locations the temperature of the reinforced concrete was higher than 500 °C [12]. Explosive spalling of the concrete cover was observed on the pillars and the beams (*Figure 8.a*). Stability failure of precast concrete wall elements and slab elements occurred, due to the failure of the steel elements (*Figure 8.b*).

*Figure 8.* a) Explosive spalling of the concrete cover, b) stability failure of concrete slab Univ. of Physical Education Oct. 2015, Budapest, Hungary [12]
