REHABILITATION OF A WOODEN ROOF SUPPORTING STRUCTURE

Summary: *The structure of the considered wooden roof of the family house, was made correctly from quality monolithic material. However, after one year of exploitation, the beams that transferred load from the wooden pillars to the walls experienced significant deformations. Therefore purlins were lifted with jacks, the deformed beams and pillars were removed and a new roof supporting structure was made. This paper presents the stress analysis with the Finite Element Method (FEM) and the construction process through all the construction stages.*

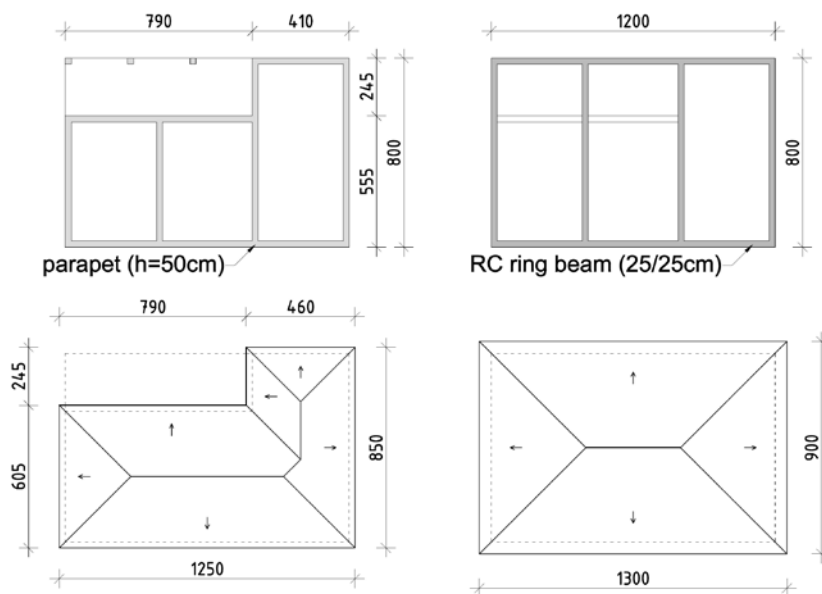
Figure 14. General view of the old roof (left) and the new roof (right)

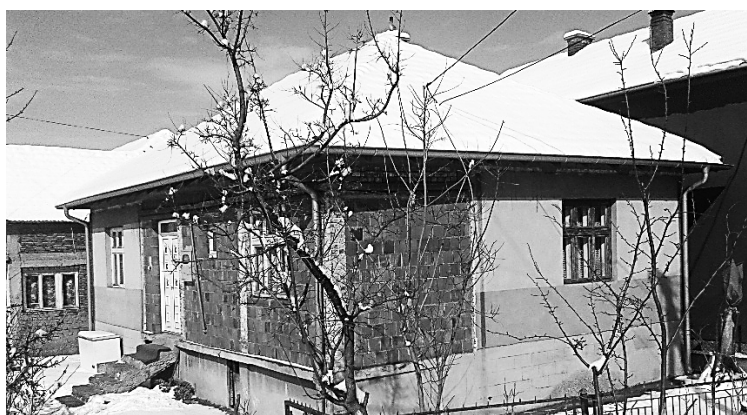
Figure 15. Rehabilitated house with a new roof structure

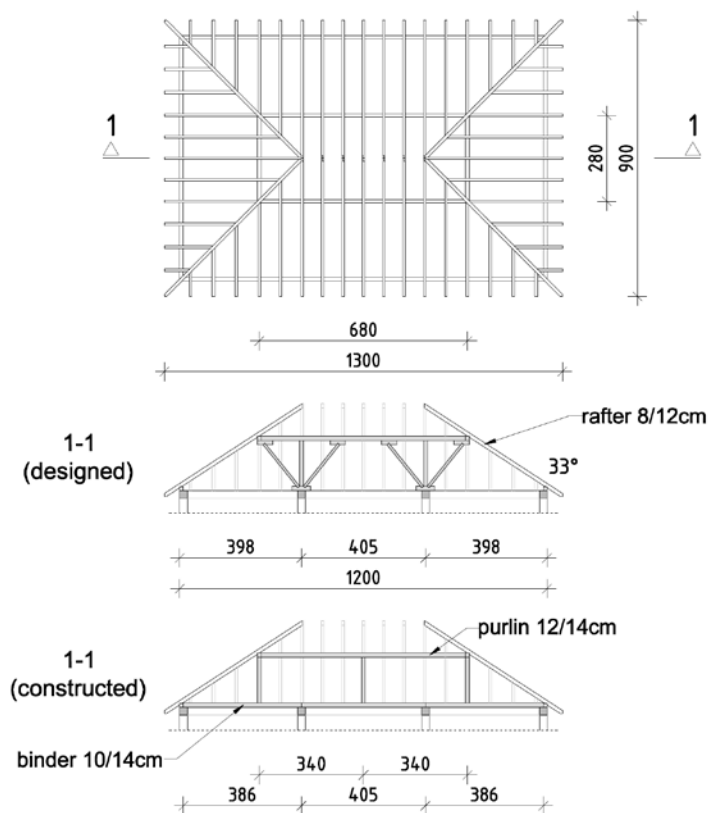
Figure 16 - General view of the roof structure (designed and constructed)

During the roof construction, the bearing structure was changed, so instead of pillars (12/12 cm) and struts (8/12 cm), the roof purlin was supported by six wooden pillars (12/12 cm), three on both sides. This construction solution required that four binders be placed between the newly constructed RC ring beams, because there were no parapet walls beneath some of the pillars. These binders' span is 386 cm and 405 cm. In this way four pillars rest on the binders, while two rest on the parapet wall.

One year after construction, the roof structure was visually assessed. Considerable deflections (up to several centimeters) of the pillar-bearing binders were noticed, which demanded the roof structure rehabilitation.

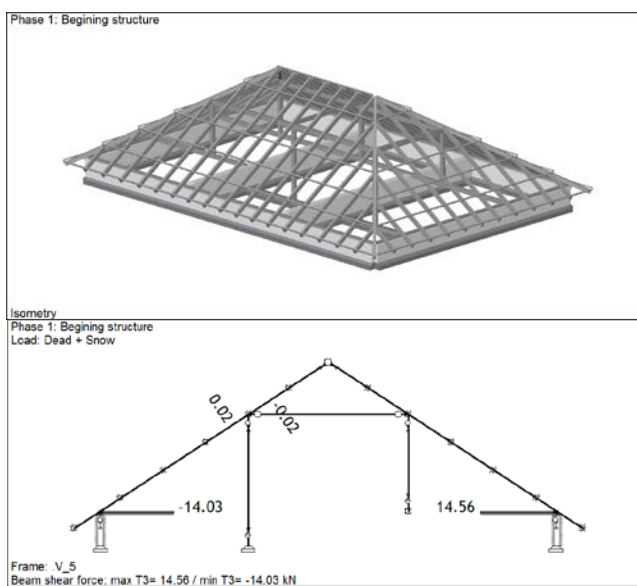
By static analysis it was established that the structure does not satisfy in terms of load capacity. Due to the very low flexural rigidity of binders, the influence of pillars is considerably diminished, and the load is transferred mainly to the eaves plates, which causes large axial forces in rafters and purlins. In the case of a full snow load effect, maximum force per nail in rafter-to-eaves plate joints is 14.56 kN , which is over 10 times higher than the nail load capacity! There was a realistic possibility of nailed joints failure in case of a full load value and the loss of stability of the whole roof structure. The axial force in the straining beam under the same loading condition was 20.49 kN , which also exceeded the load capacity of this element, because the load capacity with the cross-section dimensions of $8/12 \text{ cm}$ equals 17.25 kN [1]. Fortunately, this load state was not realized, because there was no snow during that year.

Figure 17. Spatial model and shear forces in nails in connections (14.56 kN) (Tower 6)

The main reason for roof rehabilitation was the exceeding of the nail load capacity. It was necessary to construct the purlin supporting structure that would safely transfer the loads to the bearing walls, i.e. to build the roof supporting structure that was originally designed.

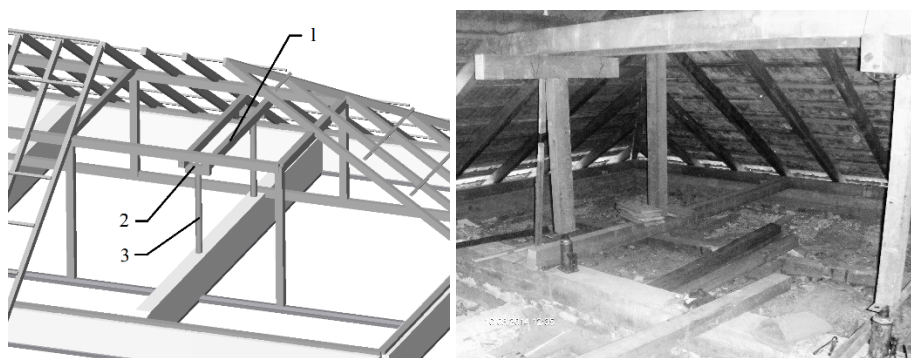
Figure 18. Scaffolding structure, left: model, right: structure „in situ“

(1. beam 10/14 cm, 2. needle 10/14 cm, 3. dead shore 8/12 cm)

In the order to remove binders and pillars and assemble the new supporting structure of pillars and struts, the present structure elements needed to be relieved from the roof load first. This meant certain uplifting of the purlins by hydraulic jacks, as it is commonly done with composite structure elements [2]. The most suitable position for the jacks

would be on the verticals going through the new RC ring beam and purlins. However, since the new wooden pillars should be put at these positions, it was decided to move the jacks closer to one another for 20 cm, and support them with an additional wood scaffolding (Fig. 5). This structure consisted of two beams (1) (10/14 cm) of 300 cm length connecting the purlins, two short beams (needles) (2) (10/14 cm) 60 cm long that run under the main beams, and two dead shores (3) (8/12 cm) under which are the hydraulic jacks located. Beams (1) are at 40 cm distance from each other. Element disposition like this enables acting on purlin without interfering with assembling of the new pillars. In order to obtain the required purlin lifting value, the statical analysis was done with respect to the construction stages. Original intention was to lift the purlins for 10 mm. During the statical analysis, the lifting values were varied between 5 mm and 10 mm, and it was concluded that there is no need to lift the purlin for more than 5 mm.

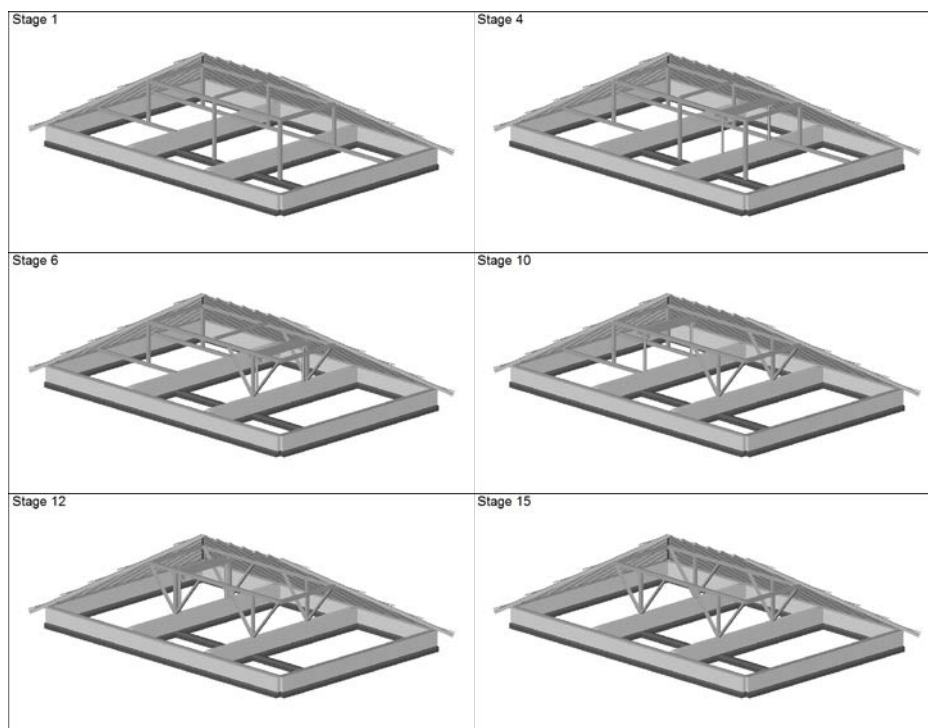
Figure 19. Some of construction stages

1. Original roof structure loaded by self-weight and snow
2. Original roof structure loaded only by self-weight, without snow
3. Scaffolding assembly on the eastern side of the structure
4. Lifting of the eastern side of the structure
- 5, 6. Dismantling of the existing structure and assembling of new pillars and struts
- 7, 8. Dismantling of the scaffolding from the eastern side of the structure
9. Scaffolding assembly on the western side of the structure
10. Lifting of the western side of the structure
- 11, 12. Dismantling of the existing structure and assembling of new pillars and struts
- 13, 14. Dismantling of the scaffolding from the western side of the structure
15. Rehabilitated roof structure loaded by self-weight and snow
