## RENOVATION OF THE FACADE OF A MONUMENT BUILDING ON ANDRÁSSY AVENUE IN BUDAPEST

**Summary:** *The paper shows the general characteristics of restoration of national monument building on Andrassy Avenue. The article presents the renovation works of the buildings façade. The task is to develop materials, procedures and methods to be used during the restoration, and to determine it in case of using individual technology. Quote from restorer report: Hübner House was built in 1882-1884... the protruding terraces on the facades is rough limestone. The puppets are bodies of rotation. They are already badly damaged, weathered and cracked in their material. In several places, only the gypsum bark surrounding the puppet is present. The condition of the elbows is variable, in any case severely damaged and eroded. There are also larger deficiencies in several places. At their plinths, dirt accumulated on the stone slabs of the terraces clogged the carved spouts, so the moisture accumulated there accelerated the deterioration processes. Repairs with cement or lime materials can be seen in several places, but none of them could replace the original work, they are of substandard quality. In or

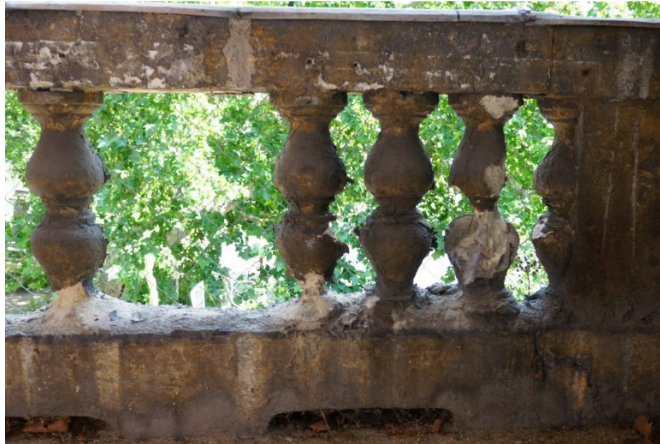
The restorer report says: ...the puppets are already badly damaged, weathered and cracked in their material. In several places, only the gypsum bark surrounding the puppet is present. The condition of the elbows is variable, in any case severely damaged and eroded. There are also larger deficiencies in several places. At their plinths, dirt accumulated on the stone slabs of the terraces clogged the carved spouts.

*Figure 2. The puppets are badly damaged*

There are also larger deficiencies in several places. At their plinths, dirt accumulated on the stone slabs of the terraces clogged the carved spouts, so the moisture accumulated there accelerated the deterioration processes. Repairs with cement or lime materials can be seen in several places, but none of them could replace the original work, they are of substandard quality (Figure 2. – Figure 5.).

The surfaces must be cleaned with stone sculptural restoration work, the defects must be corrected, and the deficiencies must be replaced in the pattern of the existing originals.

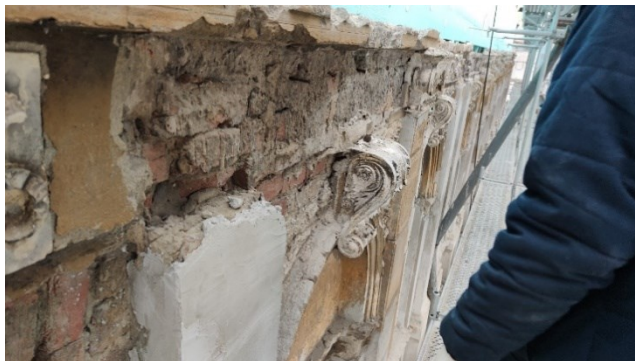
*Figure 3. The façade surface*

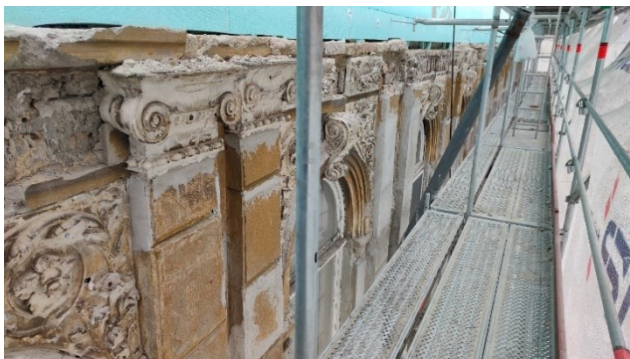
Figure 4. The window decorations

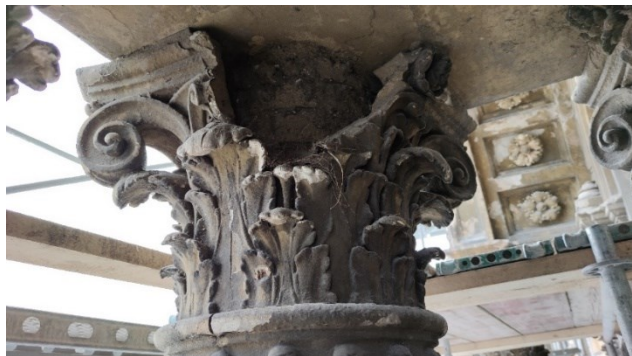
Figure 5. Column head damage
