REPARATION OF THE ENTRANCE COLUMNS OF THE NATIONAL THEATRE IN SUBOTICA

This paper describes a particular case of reparation of columns at the entrance part of the National Theatre in Subotica, problems documenting the current situation, the technical solution for the construction and used materials.

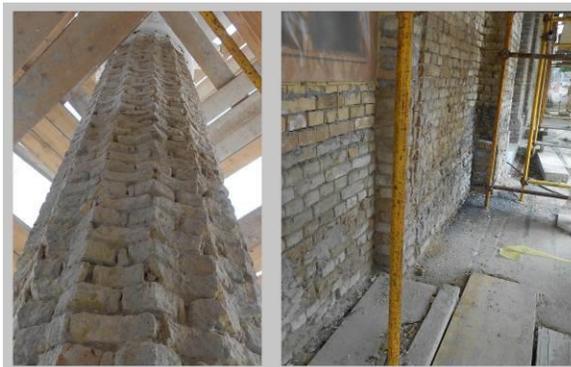
At the time of entering the business, the facade of the old building oriented to the Corso was near the completion of the works. Segments of the building for reparation were stripped to the brick substrate layer (Figure 1), both on the façade and front columns. The capitals of the columns were formed and did not enter the scope of work.

Figure 1. On site situation of the facade and columns

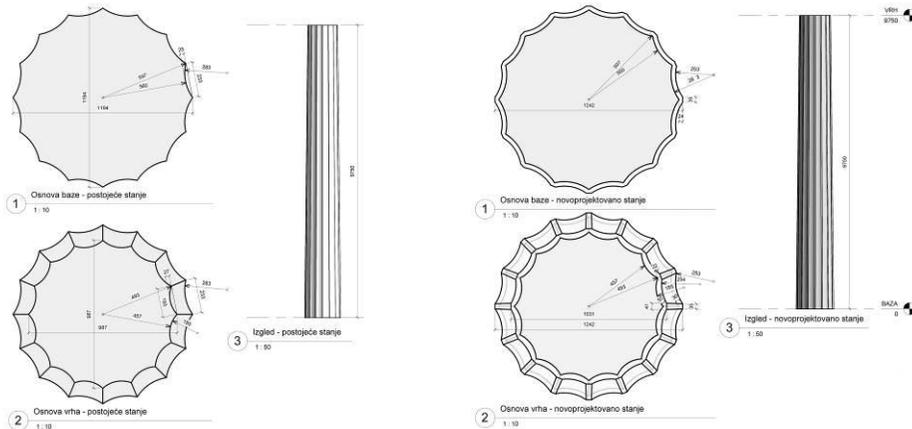
Figure 2. Cross section of existing column and newly defined volume

From the beginning it was being deliberated of the formation of a certain type of frame that should give a new definition of column volumes. Also at an early stage, with the consent of the supervisory authority, the idea of fluting with a sharp final edge, as it was in the original decision in 1854, was abandoned on the ground and it was assumed that this strongly defined verticals give greater possibility of perceiving shape irregularities that might occur. The reason for enlargement of fluting tops is derived from the fact that this solution gave the opportunity for a better definition of the final volume of the pillar. Contractor team² conceived segment metal frame that defined the final dimensions of the pillar. Mastering of the conical shape is solved by performing a frame in five segments that are at the bottom and the top merged with circular metal rings. They hardened

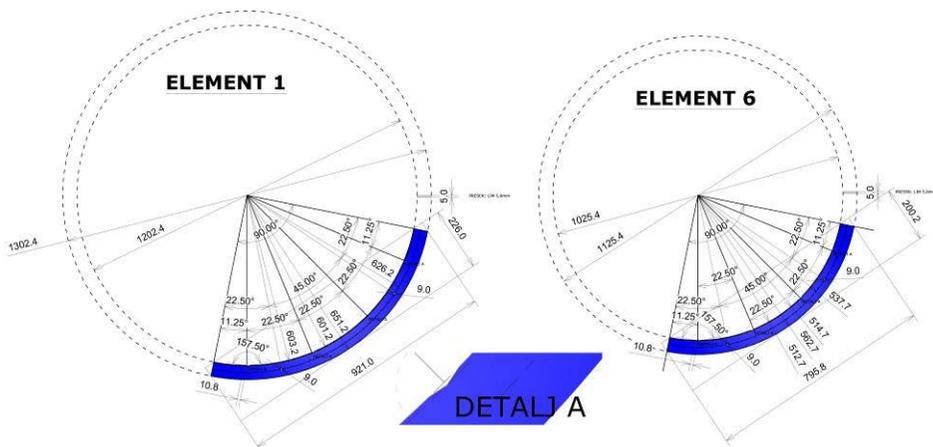
Figure 3. Frame segments for the column volume definition

vertical metal flanges which are set as the trailing edge of the fluting and are tracks for arc scratchers which formed concave parts of the pillar. The segments are set one upon other, mutually merged with eight screws, forming an overall height of 9.75m. Each segment of the guide rails, as well as the upper and lower ring, is composed of four parts for easy assembling and dismanteling.

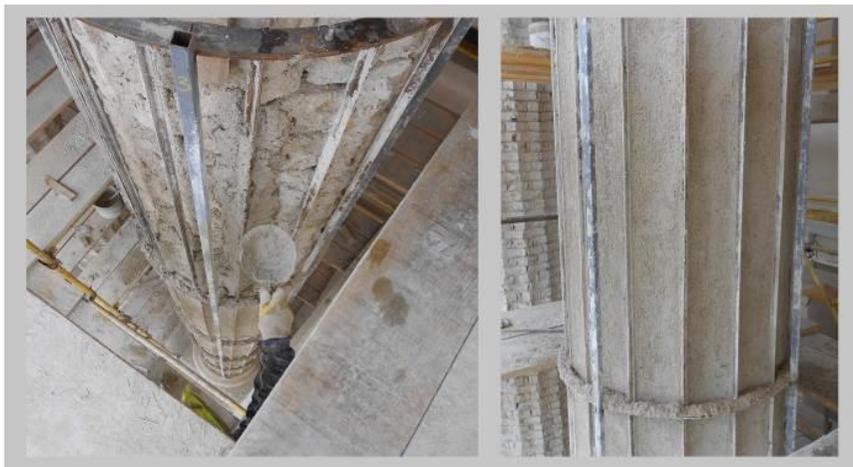
Figure 4. Metal frame

Fixing and good position of vertical guides was solved with their indenting in the ring, which minimized mistakes and twisting. Designing and forming of such a frame responded to a few basic requirements:

1. strong definition of a final shape with minimal space for error
2. easy installation and removal without damaging the pillars form
3. frame segments that are available on the market

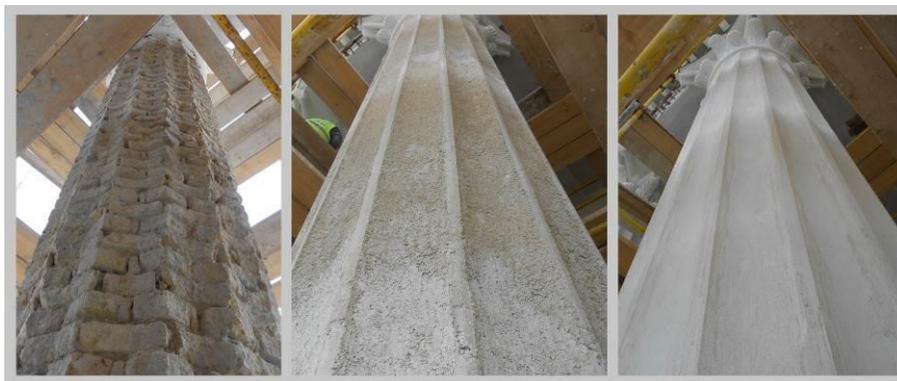
Figure 5. Work fazes – brick, rough layer, smooth layer

Four layers of mortar were done upon the brick pillar construction:

1. RÖFIX 675 hydraulic lime syringe with a thickness of $d = 0.5$ cm
2. RÖFIX 695 hydraulic lime mortar to renovate in a thickness of $d = 2-2,5$ cm
3. Primer RÖFIX AP 300 Primer, relieved at a ratio of 1:5
4. RÖFIX 380 hydraulic lime fine plaster in two layers $d=0,4\text{cm} \times 2=0,8\text{cm}$

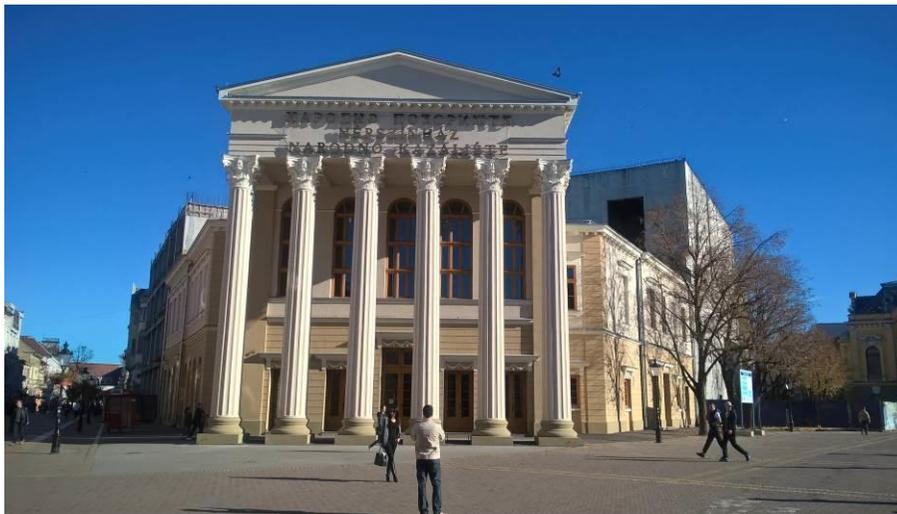
Figure 6. Building after the renovation
