## RESTORATION OF A NATIONAL MONUMENT BUILDING ON MARGARET-ISLAND

*Summary: The paper shows the general characteristics of restoration of national monument building Palatinus Bath. The Open-Air Bath, located on the Margit island, in a nature conservation area, was opened as a beach on the bank of the Danube in 1919. With the construction of the large pool it was transformed in 1921 into an open-air bath. Based on its high popularity demand it had to be expanded The t architectural project tender was launched in 1937, and the design project of István Janáky was accepted. The current installation Has been completed on the basis of these plans. The water to the pools are supplied from the thermal springs of the Margit Island.*

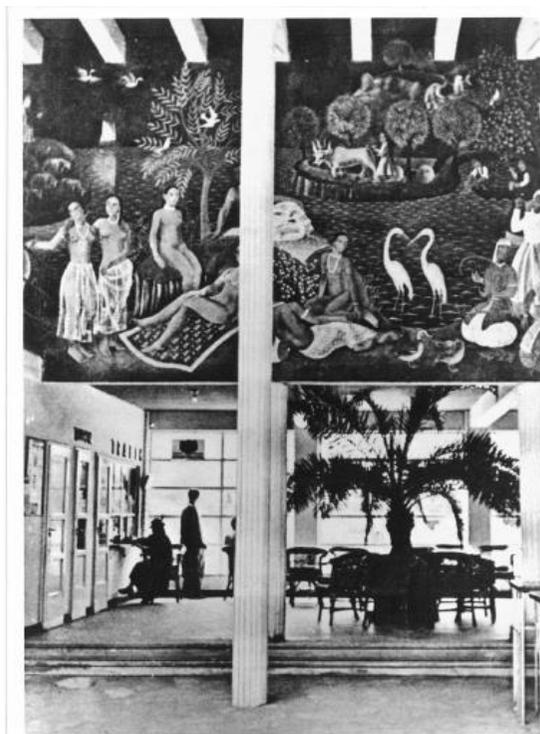
*Figure 1. The main entrance in 1937*

The investigation of the building structure and building materials was finished in 2013. The most important question was the stability of construction [1] [2]. During the same time the restorer exploration was completed [1]. The findings were very nice because on brick wall there is a rest of „secco“ (Figure 1.,Figure 3. and Figure 4.) but other wall-paintings have to be reconstructed. It was discovered that the building materials and the building structures, including the columns, walls and the ceilings were made from aluminate cement concrete (Figure 2. and Figure 5.).

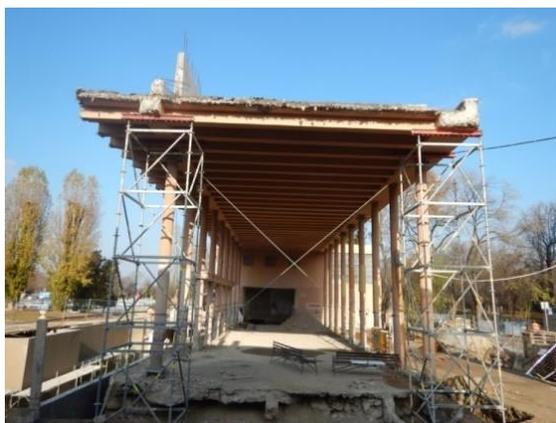
*Figure 2. The main entrance in 2016*

The building of Palatinus Bath could be divided into three wings: south-wing demolished and constructed again, north-wing partly demolished and reconstructed, central-wing with main entrance could be reconstructed (Figure 2.) and the 18 columns will remain without intervention. The monitoring (supervision) is made by Monumental Protection Agency.

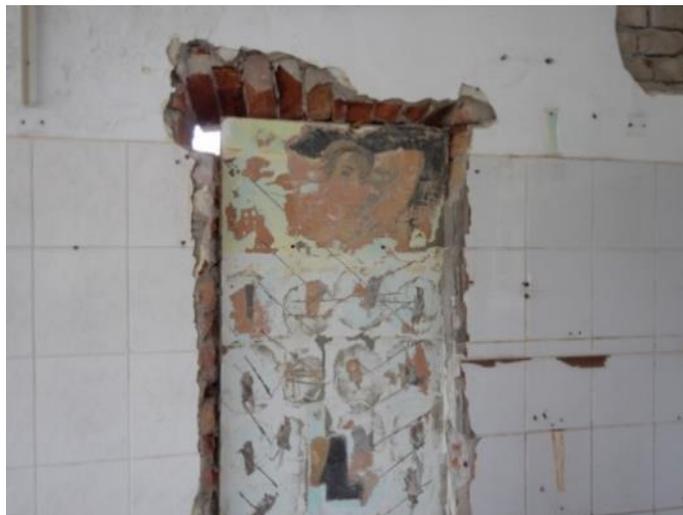
*Figure 4. Restorer trove in brick wall*

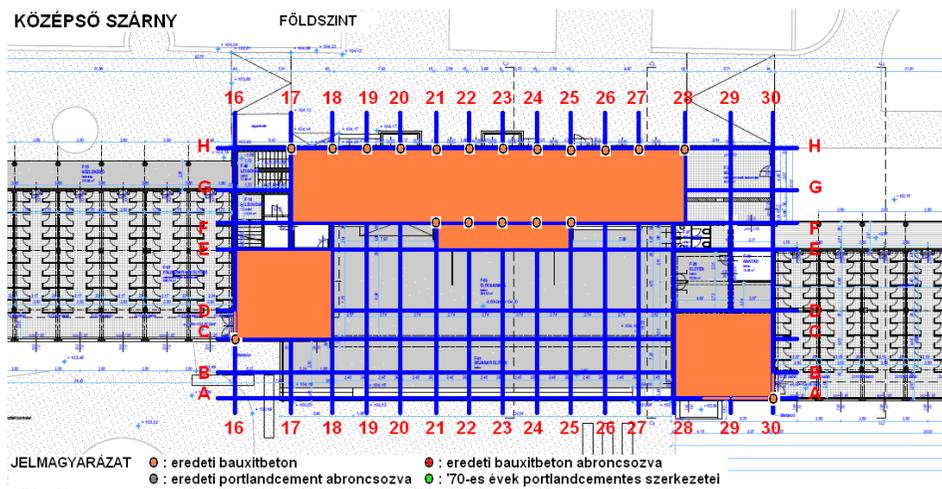
Figure 5. The state on the beginning of reconstruction

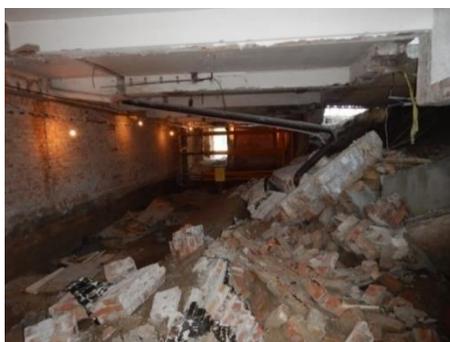
Figure 6. Basement brick wall is collapsed

The renovation started in 2016 because concerns of the stability of the building. On Margaret-island is the ground water level (GWL) very high (maximum level of GWL is on the surface). In case of flood the water level in Danube-river is above the ground. The acting water pressure (up-lift) is high too and it was taken into consideration in the design process. During the construction the basement wall crashed down on length of 21 meters (Figure 6.). It was caused by the high groundwater level. Additionally, the soil behind the basement wall had the uniformity coefficient smaller than 3-5. The building has had a large deformation but didn't crash down. With 100 tons weight was loaded the parapet concrete wall [3] (Figure 7.). The supporting systems Doka and Peri could not be used because the big amount of debris. It must be used rapid supporting system. The situation was life threatening.

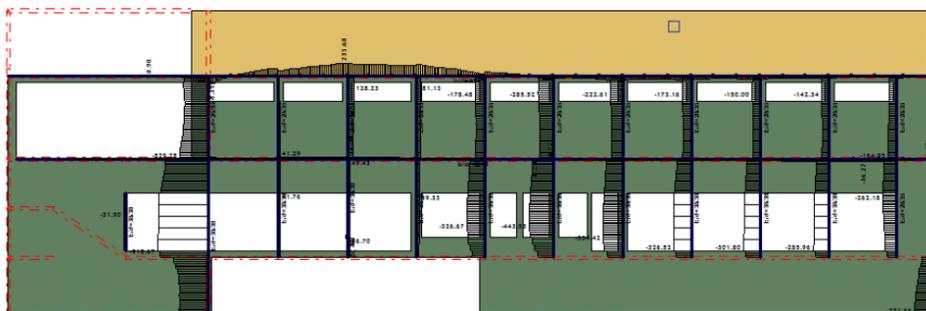
Figure 7. The collapsed basement wall caused new strength figure [3]

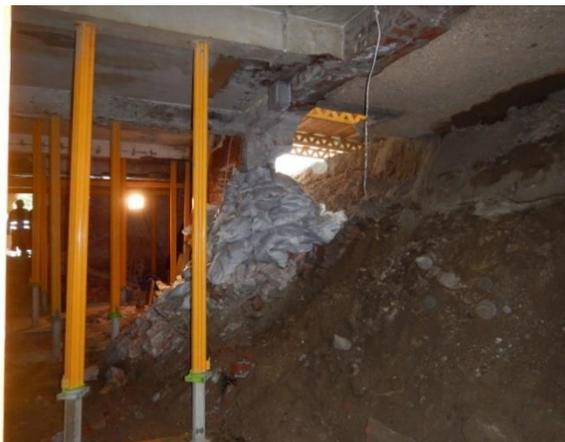
Figure 8. First concrete bag column

The new supporting system is developed, the time factor was the most important one. In case of flood the sand-bag method is used to build and strengthen the dikes. These bags were filled with fresh concrete and used for supporting of damaged construction element. The Major-method is independent from basement conditions and from carrying capacity of soil (Figure 8. and Figure 9.).

How to build the concrete bag supporting element (Major-method):

2. the bags was filled up with fresh concrete,
3. concrete quality must be C16 or higher and with very low fluidity,
4. with using of concrete bags is built a column in form of cone, empty in the middle,
5. the bags were sprayed with water to accelerate the hardening of concrete,
6. on the end the hole in column will be filled with concrete,
7. a supporting column is ready.

The concrete column has distributed the 500 kN force on the ground soil (4 m<sup>2</sup>) and the acting pressure was very low. The stability of building was preserved with no risk.

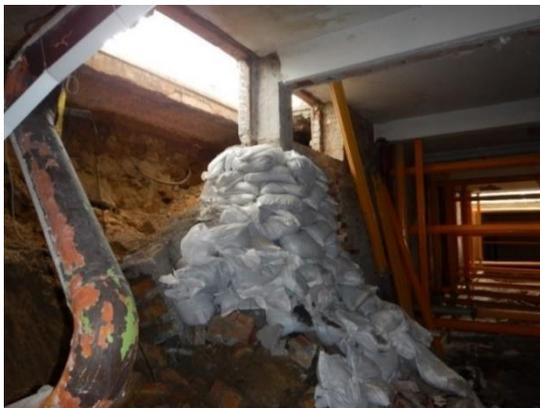
Figure 9. Second column is made with concrete bags

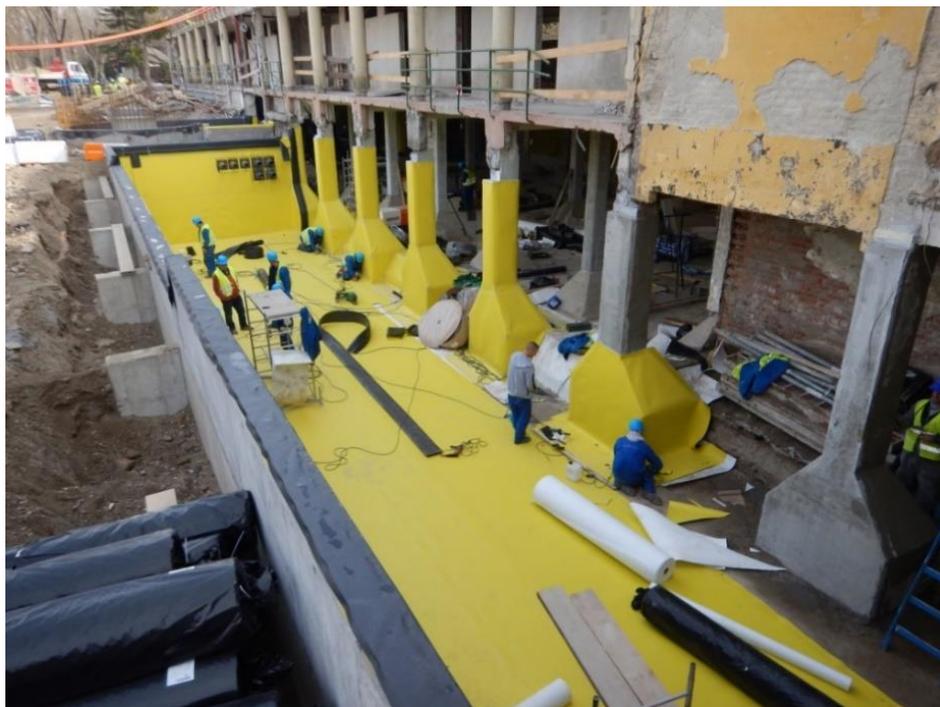
Figure 10. Hydro-isolation work of north-wing

Sika membrane system is used, which could be characterised as highly flexible membrane system, which protects the concrete structure up to the highest requirements – designed for long-term durability (Figure 10.):

8. first layer was Sikaplan W Felt 500
9. second layer was Sikaplan WP 1100-20 HL,
10. 1,0 mm protecting layer Sikaplan WP Floor Sheet-12H
11. 50 mm thermo-insulation Bauder PIR FA TE
12. 40 mm concrete.

On top of concrete layer has finished the reinforced concrete structure.
