PRINCIPLES OF DESIGNING FAÇADE CLADDING BRICK WALLS

Paper type: Original scientific paper

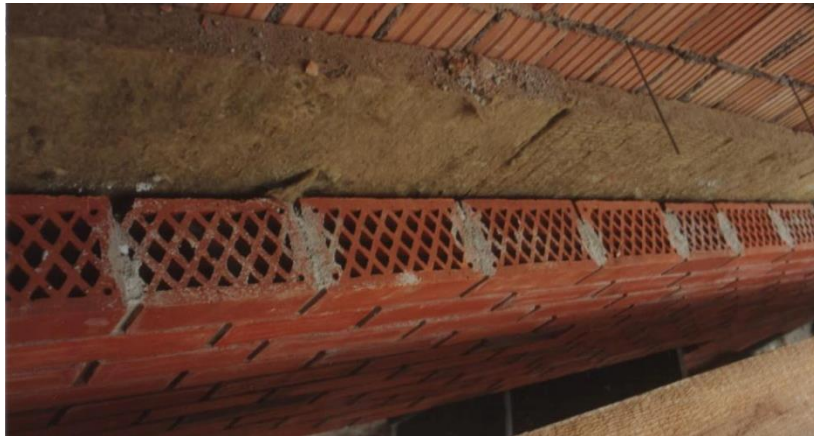
Figure 2: Paving brickwork during construction²

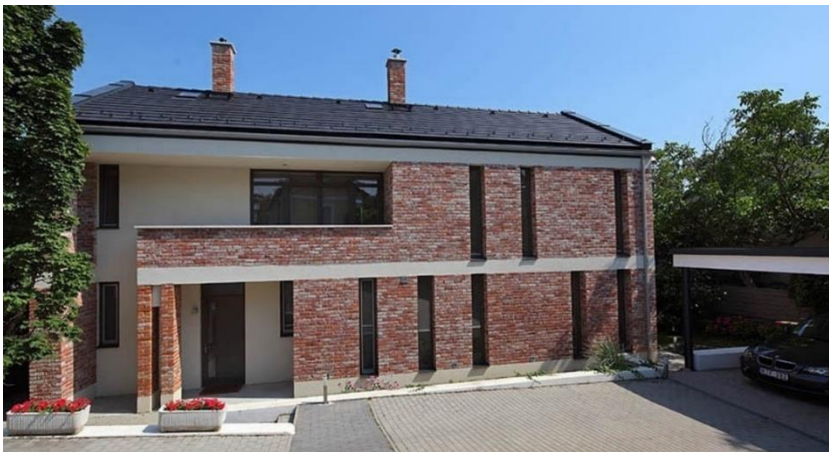
Figure 3: ventilated facade brickwork, the completed building³

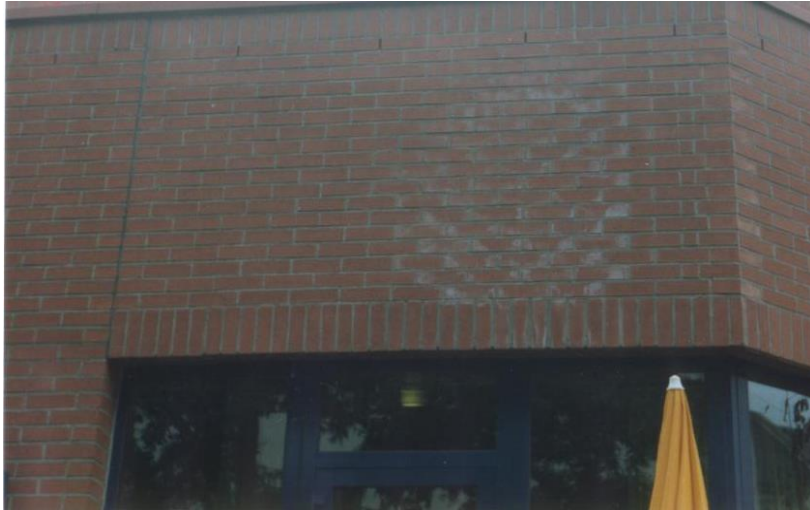
In the case of incorrectly executed external walls clad with bricks, visible or cladded walls exposed to moisture or rain may experience efflorescence. Efflorescence – besides being caused by the building material itself – is often a consequence of poor execution. The porous structure of the brick allows harmful substances such as SO_2 , CO_2 to be absorbed into the building material, where they can react with moisture to form sulfuric acid. This acid then reacts with the free calcium carbonate present in the building materials, forming a salt solution that moves towards areas with lower vapor pressure and appears on the surface of the cladding, where water evaporates, leaving behind the salt. This deposition primarily results in aesthetic damage, but if the masonry continues to receive moisture continuously, it ultimately leads to the deterioration of the masonry.

Figure 4: Salt efflorescence on the wall surface⁴

The consequences of this can be as follows: if there are remnants of mortar in the joints, moisture can seep into the mortar layers of the masonry during rainfall. These mortar layers, due to their lime content, are good absorbents of moisture, leading to saturation of the entire masonry. The consequence is efflorescence, caused by salts dissolved from the

masonry by water. Further damage occurs during freezing conditions when water in the joints causes the outer part of the grouting to spall.
