CONCRETE CORROSION ON A PRIMARY SETTLING TANK

Paper type: Original scientific paper

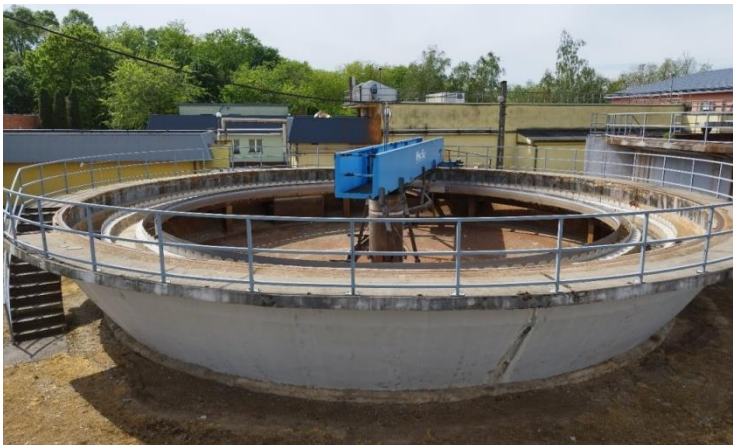
Figure 1: The number three primary settling tank

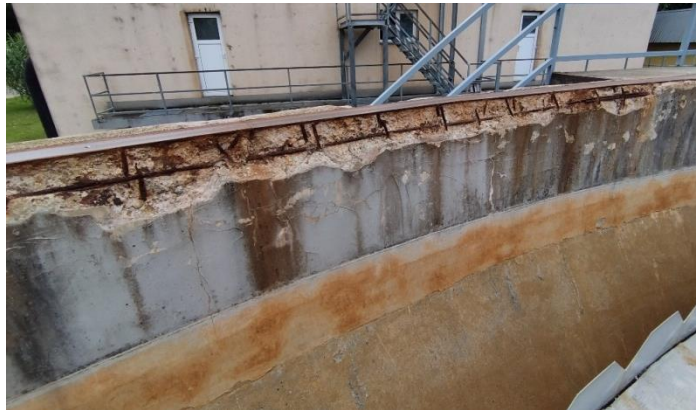
The on-site inspections were conducted by visual examination. Since the settling tank has been drained for 2 years, the inside of the tank was clearly visible, showing how discoloured the concrete surface was. The concrete cover had come off in several places, the reinforcing bars were exposed, cracks were visible, and the scraper bridge and mechanical equipment were corroded. The presence of lime was visible on the outside walls of the settling tank, the concrete bottom was crusted where the scraper wheels run, and the concrete cover had come off from the underside of the cantilevered service walkway.

Figure 2: The missing concrete cover from the inner part of the tank edge

In specific areas where the concrete cover had either completely fallen off or decreased, the concrete became porous and exhibited a lower pH value, leading to localized steel corrosion. These observations indicate that while there are some concerns, they are not widespread enough to undermine the overall structural health. Such issues can be effectively managed with appropriate maintenance measures, including the application of protective coatings and regular monitoring to prevent further deterioration.

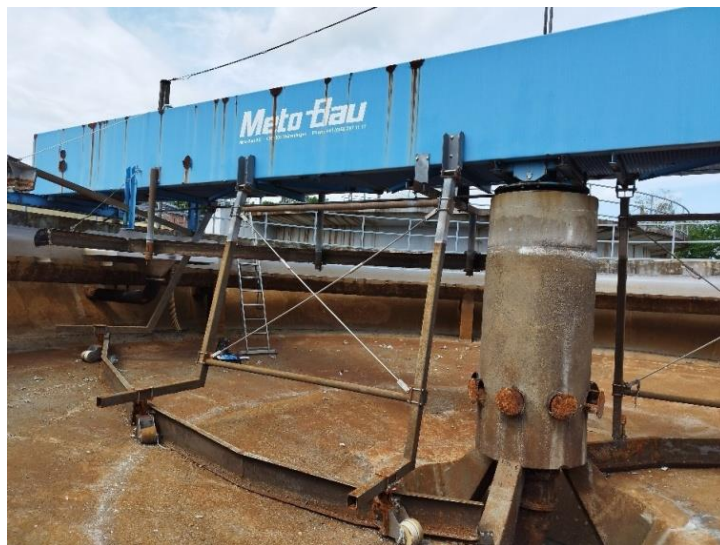
The on-site examinations commenced with a visual inspection of the structure. Given that the pool had been drained for two years, the interior was clearly visible, revealing significant discoloration on the concrete surface. Observations indicated several areas where the concrete cover had detached, exposing the reinforcing steel bars. Cracks were visible, and corrosion was noted on the scraper bridge and mechanical equipment. Externally, limestone efflorescence was observed, and the pool bottom exhibited crusting in areas where the scraper wheels run, along with detachment of the concrete cover from the underside of the cantilevered service walkway. To assess the concrete's condition accurately, six specific measurement locations were selected for the Schmidt hammer test. These sites were strategically chosen to reflect different states of the concrete surface, providing a comprehensive understanding of the structural integrity. The selected areas displayed varying degrees of degradation: some showed significant wear and detachment, while others exhibited surface-level cracking and discoloration.

Figure 3: Wear of the tank's bottom plate along the wheels

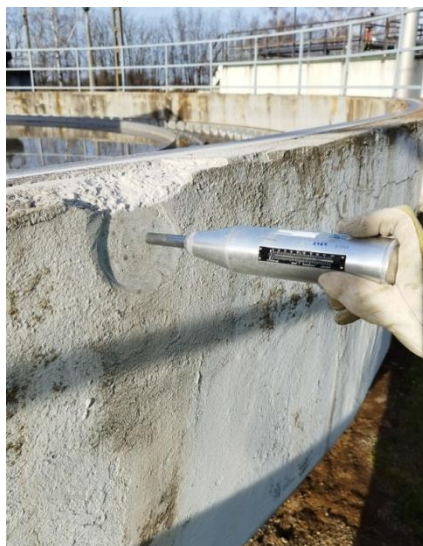
For the assessment, a Schmidt hammer, commonly known as a rebound hammer, was employed. The Schmidt hammer, also known as a rebound hammer, is a non-destructive tool used to evaluate the surface hardness of concrete and estimate its compressive strength. During measurements, the hammer is held perpendicular to the concrete surface, and a spring-loaded mass is released to impact the concrete [12]. The hammer then measures the rebound distance of the mass, which is read on a graduated scale. This rebound value is indicative of the surface hardness of the concrete: the higher the rebound value, the harder and potentially stronger the concrete. Multiple readings are typically taken at various points on the concrete surface to ensure accuracy and account for any surface irregularities. The average of these readings is used to estimate the concrete's compressive strength, providing valuable data for assessing structural integrity.

Based on the non-destructive testing, the current compressive strength class of the settling tank's concrete corresponds to C25/30, whereas the compressive strength class at the time of construction, converted to the current standard, was C16/20.

Figure 4: Concrete strength measurement on the tank edge

Relying on the measured hardness from the nondestructive tests, the estimated compressive strength of the tested concrete was 25 N/mm², corresponding to C25/30 concrete quality. However, this estimation should be approached with caution due to the limited number of testing locations, which may not provide a comprehensive assessment of the concrete's overall condition. Consequently, it cannot definitively be stated that the compressive strength has increased compared to the original, as there is no certainty about the current compressive strength or the actual strength of the concrete when it was originally placed. Despite these limitations, the condition of the structure is considered satisfactory based on several key findings.

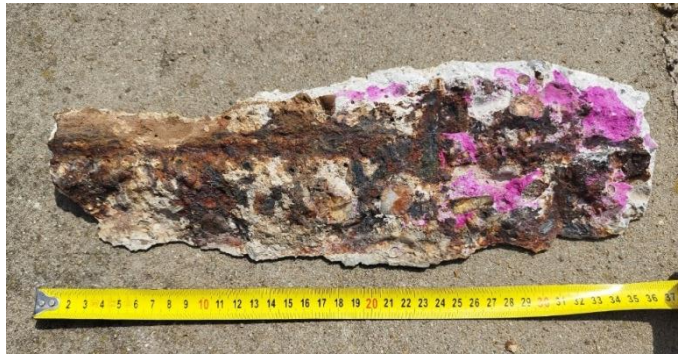
A carbonation depth check was also conducted in two places on the tank's edge. A phenolphthalein indicator solution was needed for the examination. For the measurement, the concrete cover had to be chiselled at designated locations to obtain a surface that had not yet been exposed to air, as the surface of the concrete began to carbonate from the carbon dioxide in the atmosphere.

Figure 5: Due to the porosity of the concrete and the looseness of the concrete cover, carbonation is significant, and the concrete is rusty in several places

Figure 5 shows that carbonation has reached the steel reinforcements on the fractured surface, and gaps and larger pores have also formed in the concrete. As a result, there was a hairline crack between the examined piece and the fractured surface, allowing the carbon dioxide content of the air to cause carbonation over a significant area. Where the porosity of the concrete was low and hermetically continuous with the concrete edge, the solution turned purple, indicating that the pH value was greater than 9.

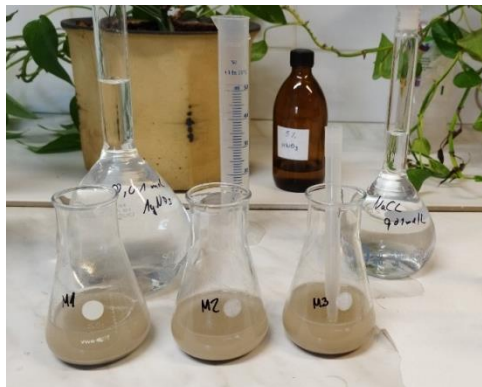
A chloride ion content test of the concrete was conducted in a laboratory, for which drill dust samples were taken from the upper edge of the structure. The measurement was performed based on the Mohr method [14], guided by the principle that chlorides react with silver ions, and in the presence of chromate ions, an insoluble precipitate will form. The tested concrete surface has a pH value of 10.5, which, although above the critical limit of 9.0 for corrosion, does not provide protection for the reinforcing bars.

Figure 6: The measured drill dust sample homogenized with distilled water

Based on the result, it can be determined that 5 g of concrete dust contains 0,0032 g of chloride ions, which is 0,064% by weight. This complies with the regulations that the chloride ion in the cement content by mass percentage must not exceed the 0,10 m/m% allowed for reinforced concrete structures according to the standard (MSZ 4798:2016/1M 2017), although the chloride content generally rarely exceeds the required limit. The results of the measurements are presented in Table 1.

The chloride content was found to be below the acceptable limit, suggesting that the concrete has not been significantly compromised by chloride-induced corrosion, which is a common cause of structural degradation in reinforced concrete. Furthermore, although carbonation had penetrated to a depth of 3-4 cm at the surface, reaching the reinforcing bars, the overall structural integrity remains intact. This conclusion is supported by visual inspections, which confirmed that, while some areas of concrete cover had deteriorated, the majority of the structure remains robust.
