## FIRE: STRUCTURAL AND MATERIAL CONSEQUENCES

Balázs L. György<sup>1</sup>  
Éva Lublóy<sup>2</sup>

**Summary:** *In addition to the mechanical properties, behaviour structural materials at elevated temperatures is also of high importance. Present paper deals with the effects of fire attack on concrete or concrete structures in Hungary. Residual compressive strength of concrete exposed to high temperatures is influenced by the following factors: water to cement ratio, cement to aggregate ratio, type of aggregate, water content of concrete before exposing it to high temperatures and the fire process. Therefore, mix design and composition of concrete are of high importance. Material and structural behavior are analyzed at high temperatures, which, based on practical observations, could reach even 1100°C in some cases. Relationship of concrete mix design and structural behaviour are discussed with test results on prestressed concrete beams. By the analysis of earlier fire attacks, important information can be obtained for future fire design. The fire cases of the Budapest Sports Hall (1999) and of the Athletic Hall of the University of Physical Education in Budapest, Hungary (2015)

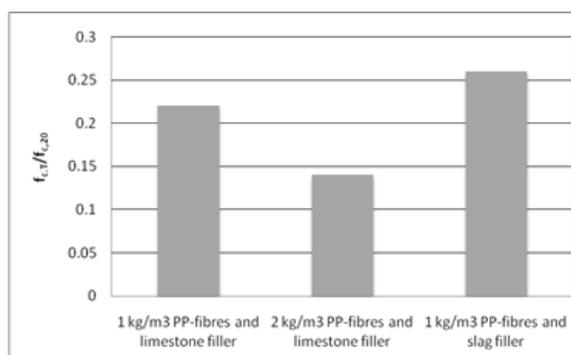
Material tests were carried out on cube specimens of 150 mm sides kept 2 hours on  $600\text{ }^\circ\text{C}$  or  $800\text{ }^\circ\text{C}$  then cooled down to room temperature. Material tests were carried out at the Department of Constructions Materials and Technologies, Budapest University of Technology and Economics. In case of our reference mix (Mix 1) a special type of failure occurred during the heating process within the temperature range of 600 to  $800\text{ }^\circ\text{C}$ . Some corners of the cube specimens cracked off. This phenomenon could be explained by the stress concentrations in corner regions due to the high temperatures. Stress concentrations in the corners may indicate deterioration of structural performance of an element or possible spalling of concrete cover. By addition of  $1\text{ kg/m}^3$  polypropylene fibres, failure of the specimen (corner cracking) did not occur, however, surface cracking was observed. By further increase of fibre content  $2\text{ kg/m}^3$  PP fibres instead of  $1\text{ kg/m}^3$ , the relative residual compressive strength decreased by about 8%. We have observed the highest relative residual compressive strength by changing the filling material from limestone to slag and including also  $1\text{ kg/m}^3$  polypropylene fibres subjected to  $800\text{ }^\circ\text{C}$  (Figure 3).

Figure 3. Measured relative, residual compressive strength values for tested concrete mixes with  $800\text{ }^\circ\text{C}$  (every point is an average of 3 measurements, relative values are related to those at  $20\text{ }^\circ\text{C}$ )

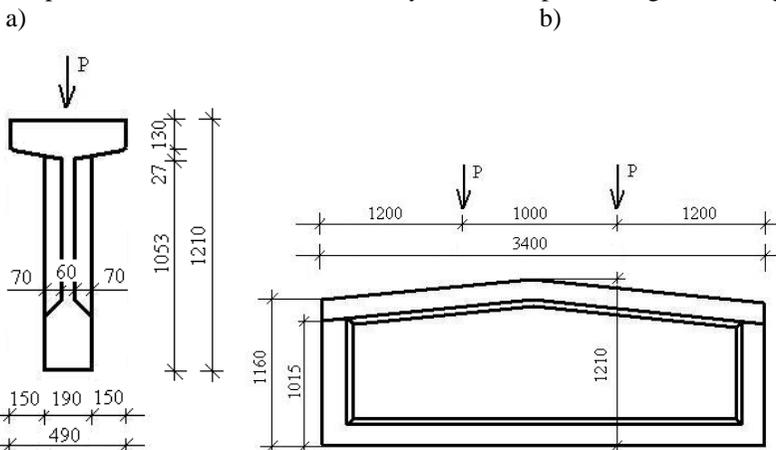
Figure 4. Tested beam specimens [6]

a) Cross - section of beam b) View of beam

The length of beams was 3.4 m. The prestressing force was 130 kN. First, the beam was loaded with  $P=2 \times 350$  kN during the fire test (Figure 4). Test beam with reference mix (Mix 1) failed in 12 minutes owing to the complete spalling of concrete cover of the web (Figure 5). Test beam with Mix 2 including  $1 \text{ kg/m}^3$  polypropylene fibres failed in 42 minutes in shear (without spalling of concrete cover). Test beam with Mix 4 including  $1 \text{ kg/m}^3$  polypropylene fibres and slag as filling material instead of lime stone failed in 67 minutes in shear (without spalling of concrete cover).
